In-situ Bioremediation of Chlorinated Hydrocarbons

An Assessment of Projects in California

California Department of Toxic Substances Control
Office of Pollution Prevention and Technology Development

February 2006

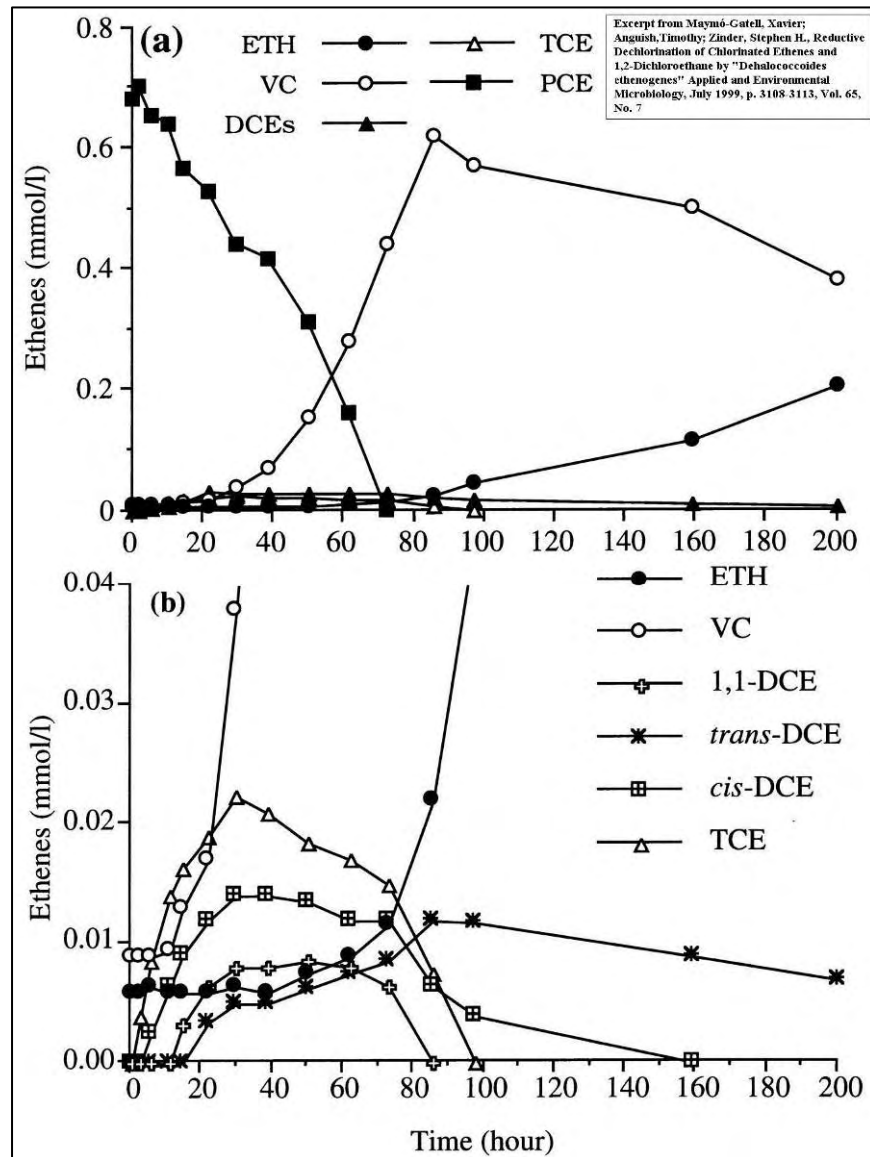
Figure 1-1. Five Examples of Different Biodegradation Patterns¹

Figure 1-1 presents are 5 plots of patterns of concentrations expected from the conversion of PCE to ethylene that would provide varying levels of confidence about the biodegradation process. The plots range from “ideal” to “no biodegradation apparent.” Intermediate situations (patterns) that might result from insufficient monitoring, “stalling” of the biodegradation process at cis-1,2-DCE, or patterns resulting from any combination of poor performance and confounding factors are also shown in Figure 1-1.

(a) Classical biodegradation pattern

Plots such as those shown in Figure 1-1 can be constructed from monitoring results where the appropriate compounds are measured. Such plots provide a clear means to monitor the progress – or lack of progress – of biodegradation of chlorinated solvents.

The idealized (and even unfavorable) patterns shown in Figure 1-1 indicate the degree of treatment that might be occurring during an in-situ bioremediation project. Along with the compounds (solvents and daughter products) being biodegraded, changes in water chemistry can be followed to determine if the environment is favorable or conducive to biodegradation. Redox potential (ORP), dissolved oxygen (DO), alkalinity, metals (notably iron and manganese), anions (nitrate and sulfate, which themselves may be added as nutrients; chloride, which is liberated at each step of the biodegradation process), and pH can all serve to characterize the subsurface environment with respect to biodegradation. Where these parameters respond in a predictable way during the implementation of biodegradation (increases and decreases as expected), there is support for determining that biodegradation is occurring.

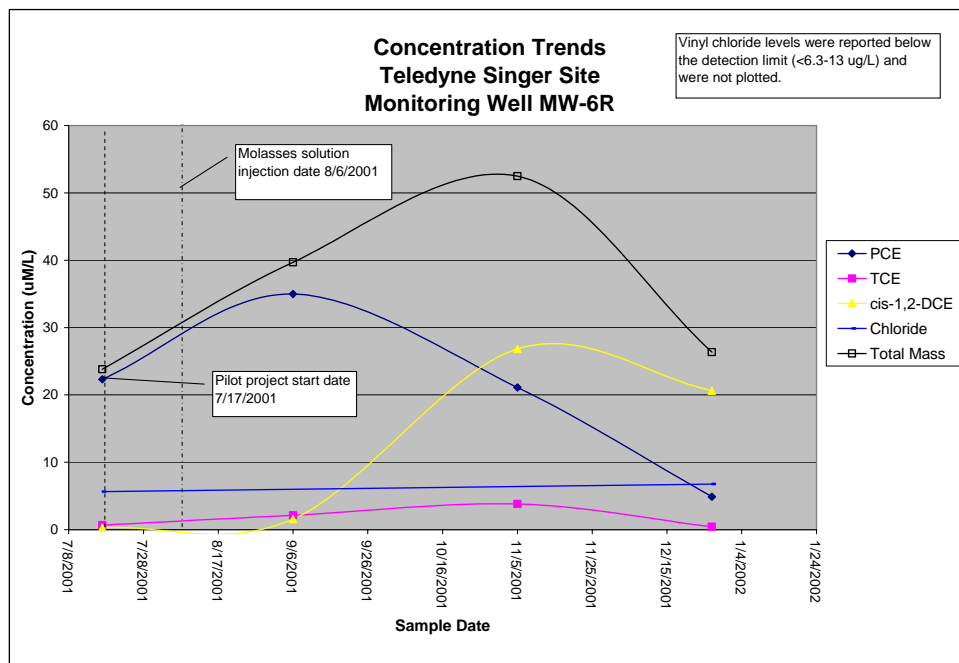
(b) Favorable biodegradation pattern

graph (concentration versus time plots). Preparation of such graphs became the prime method of analysis of groundwater data collected at the five sites selected for further evaluation in this study. Figures 1-1b through 1-1e are examples of patterns where the biodegradation conditions ranged from favorable to not occurring. These graphs are based on data from the case studies presented in Section 4.

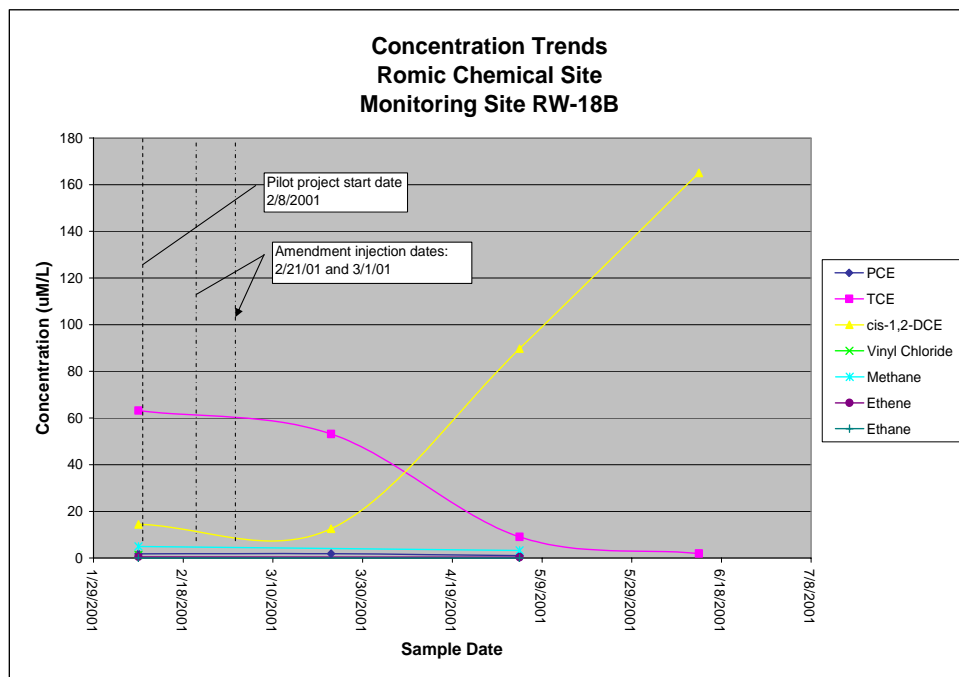
(c) Inconclusive/stalling at cis-1,2-DCE

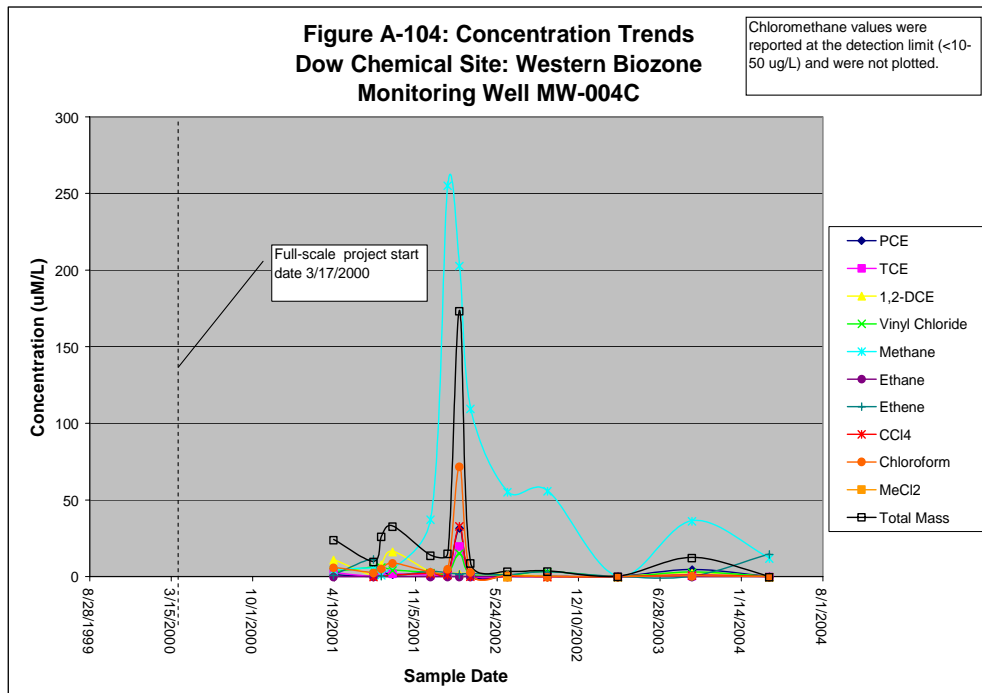
Figure 1.-1. Five Examples of Different Biodegradation Patterns (cont.)

(d) Inconclusive

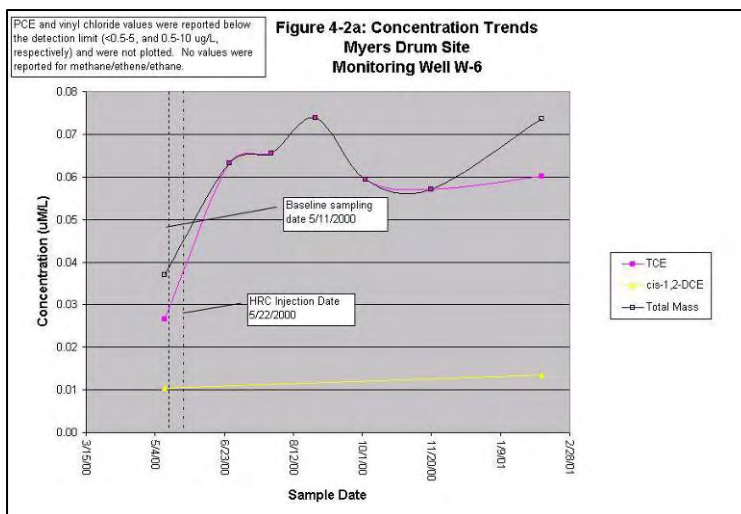
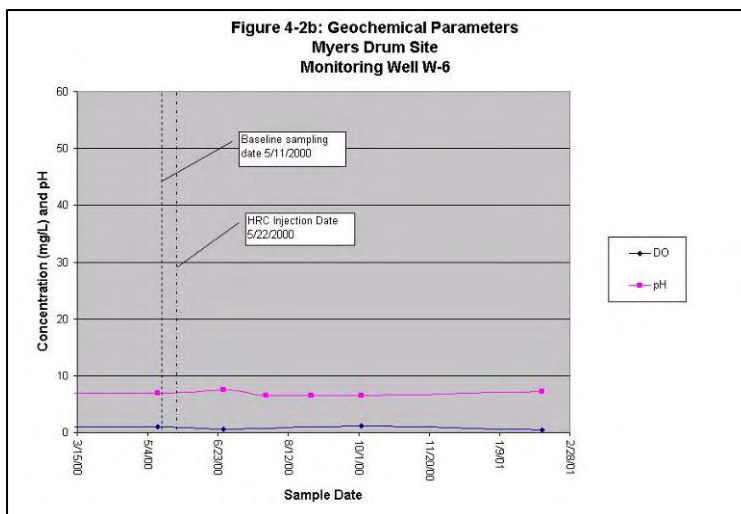
Figure 4-2. Data Analyses for Monitoring Well W-6 at the Myer Drum Facility

Well Number	Contaminant Mass Loss				Enhanced Geochemical Conditions	Increased Dissolved Gases	Evaluation Rating
	PCE	TCE	DCE	VC			
W-6		-	-				NE

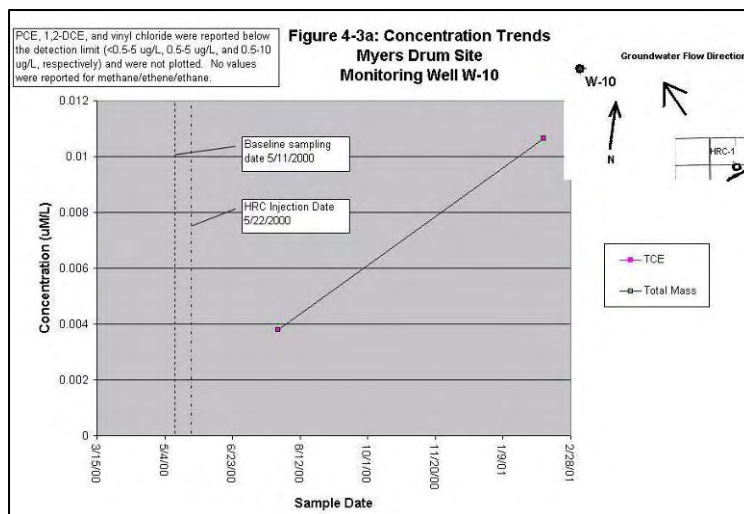
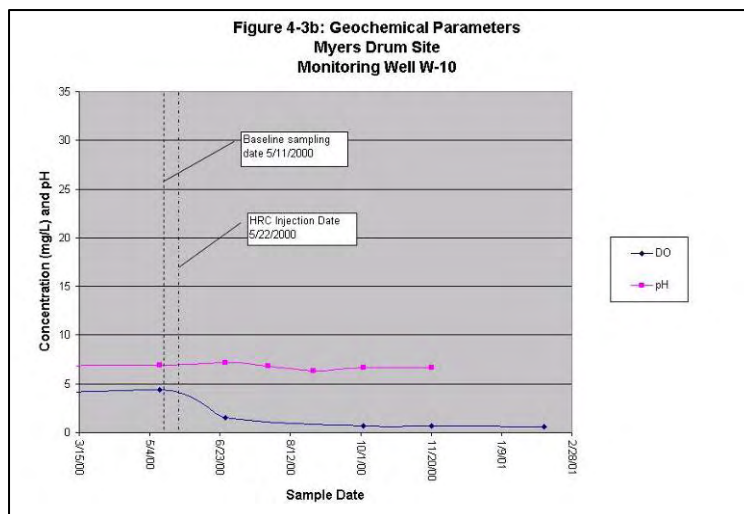
Figure 4-3. Data Analyses for Monitoring Well W-10 at the Myers Drum Facility

Well Number	Contaminant Mass Loss				Enhanced Geochemical Conditions	Increased Dissolved Gases	Evaluation Rating
	PCE	TCE	DCE	VC			
W-10		-					NE

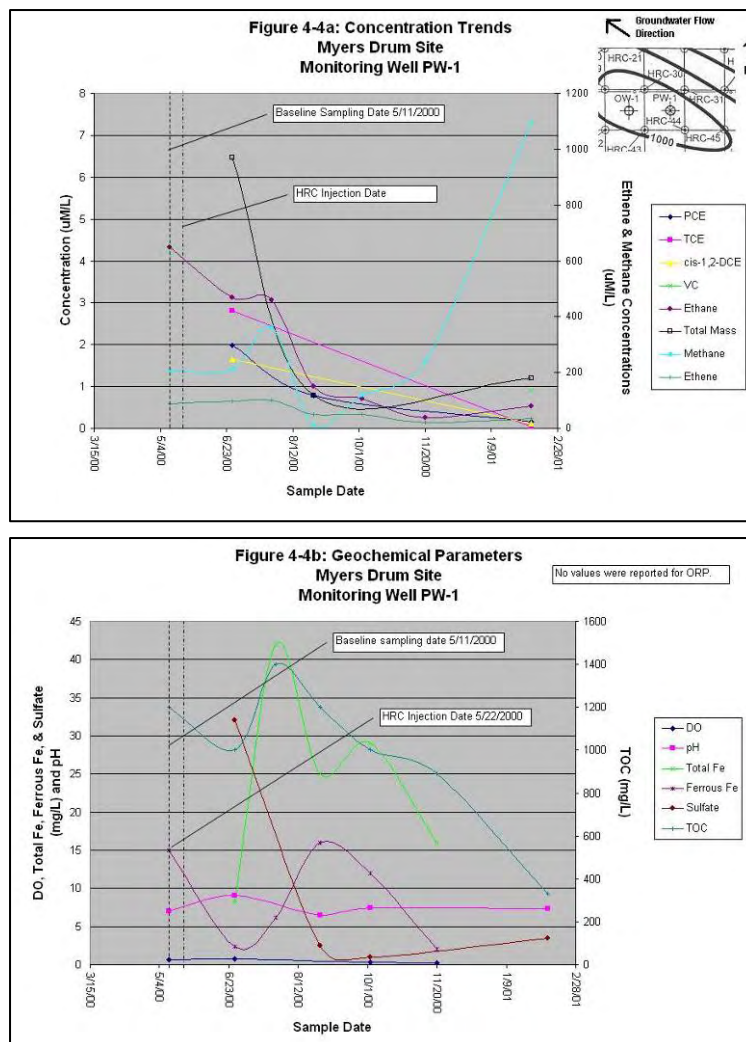
Figure 4-4. Data Analyses for Monitoring Well PW-1 at the Myers Drum Facility

Well Number	Contaminant Mass Loss				Enhanced Geochemical Conditions	Increased Dissolved Gases	Evaluation Rating
	PCE	TCE	DCE	VC			
PW-1	+	+	-		+	-	ME

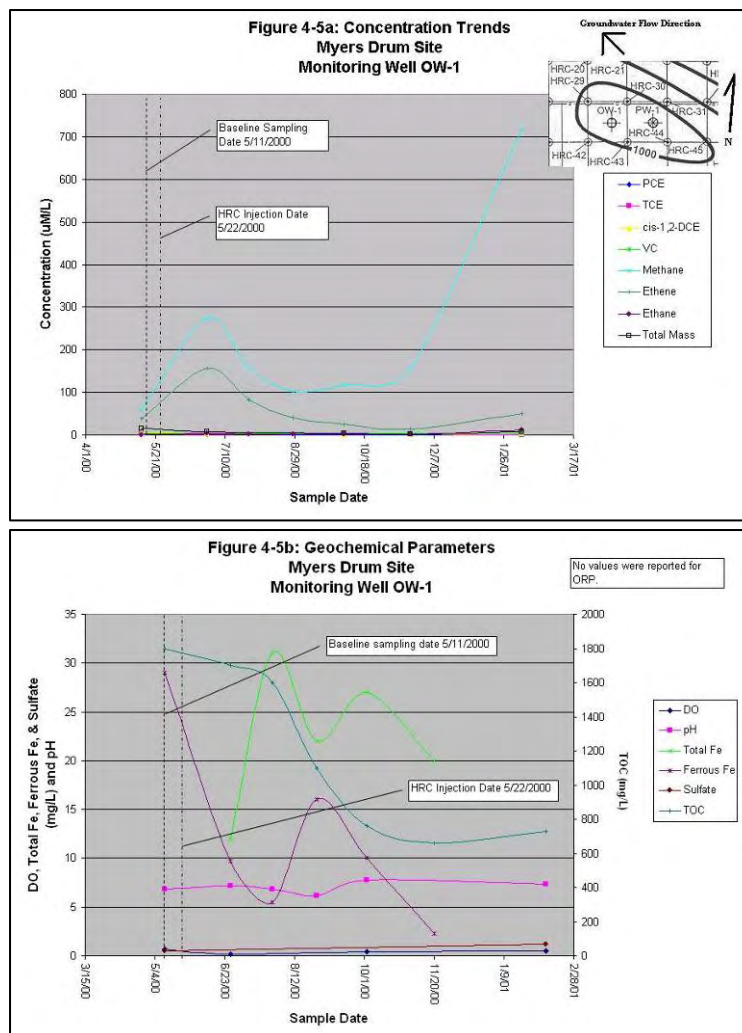
Figure 4-5. Data Analyses for Monitoring Well OW-1 at the Myers Drum Facility

Well Number	Contaminant Mass Loss				Enhanced Geochemical Conditions	Increased Dissolved Gases	Evaluation Rating
	PCE	TCE	DCE	VC			
OW-1	+	+	+	+	-	+	ME

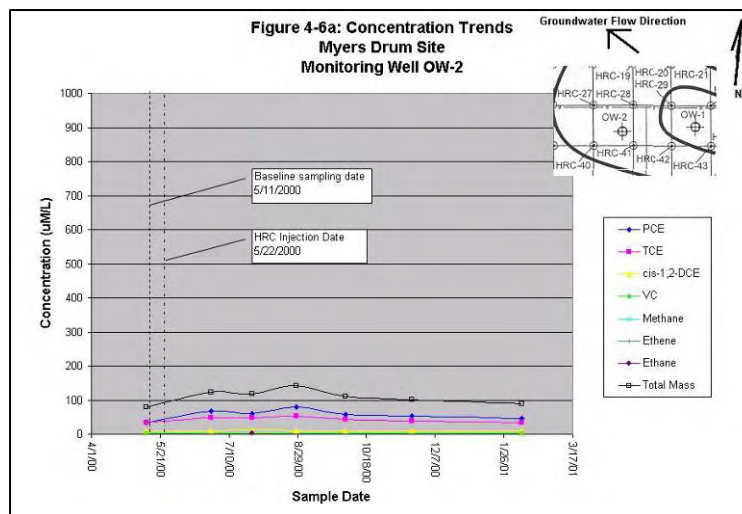
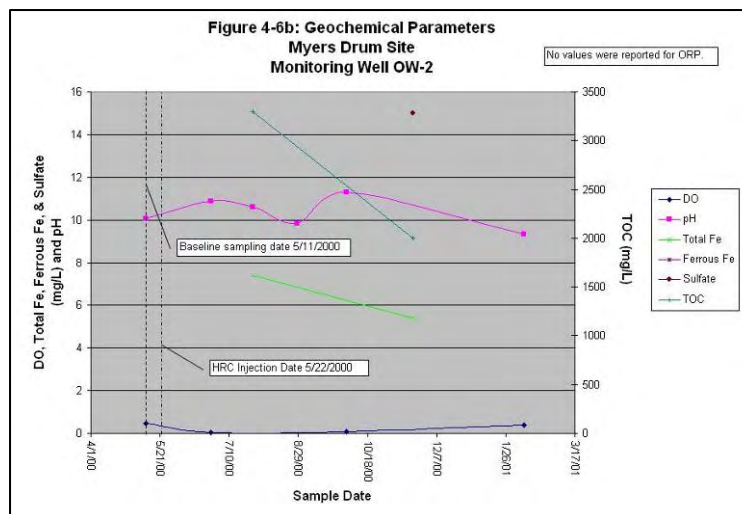
Figure 4-6. Data Analyses for Monitoring Well OW-2 at the Myers Drum Facility

Well Number	Contaminant Mass Loss				Enhanced Geochemical Conditions	Increased Dissolved Gases	Evaluation Rating
	PCE	TCE	DCE	VC			
OW-2	-	0	0	0			NE

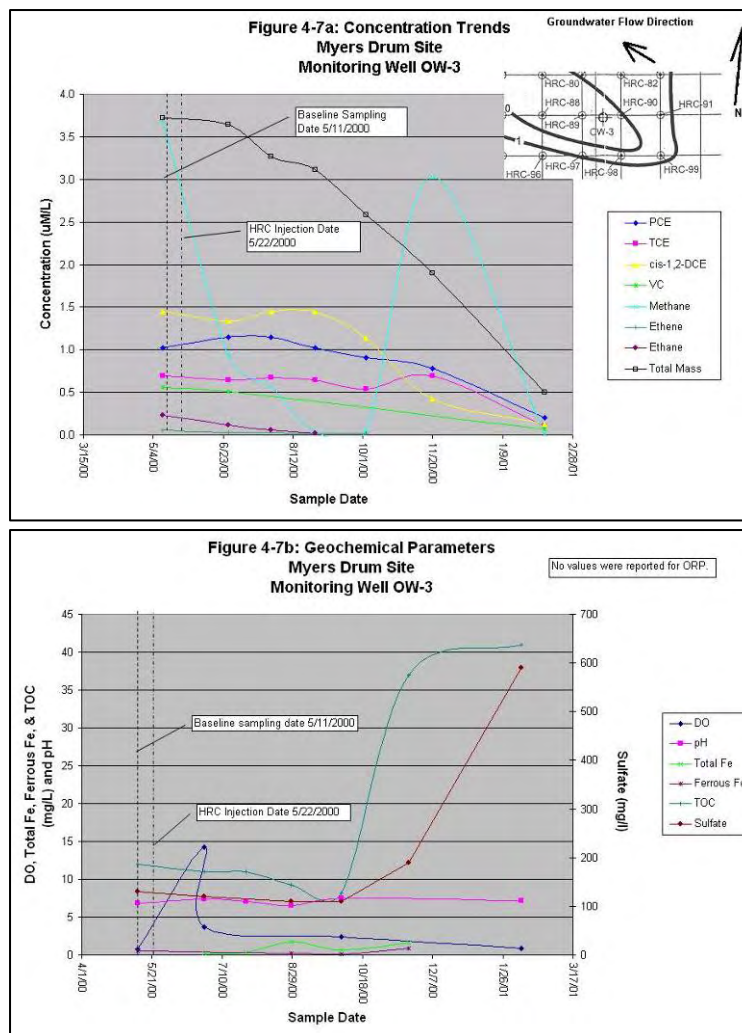
Figure 4-7. Data Analyses for Monitoring Well OW-3 at the Myers Drum Facility

Well Number	Contaminant Mass Loss				Enhanced Geochemical Conditions	Increased Dissolved Gases	Evaluation Rating
	PCE	TCE	DCE	VC			
OW-3	+	+	-	0	-	-	SE

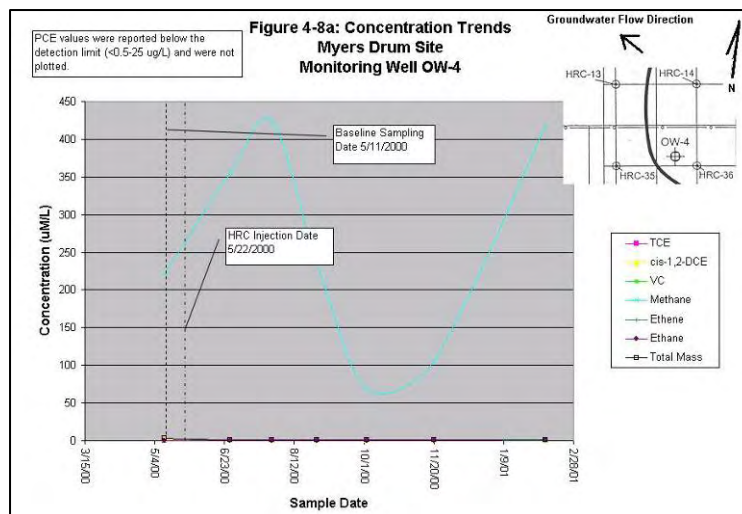
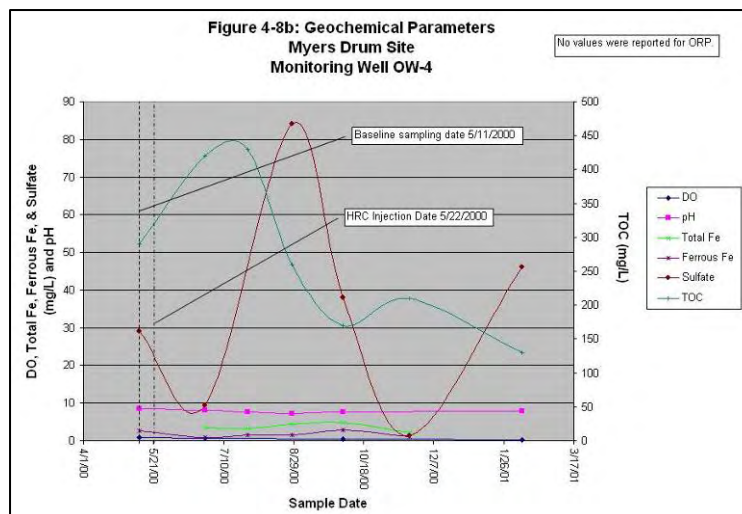
Figure 4-8. Data Analyses for Monitoring Well OW-4 at the Myers Drum Facility

Well Number	Contaminant Mass Loss				Enhanced Geochemical Conditions	Increased Dissolved Gases	Evaluation Rating
	PCE	TCE	DCE	VC			
OW-4		-	-	0		+	SE

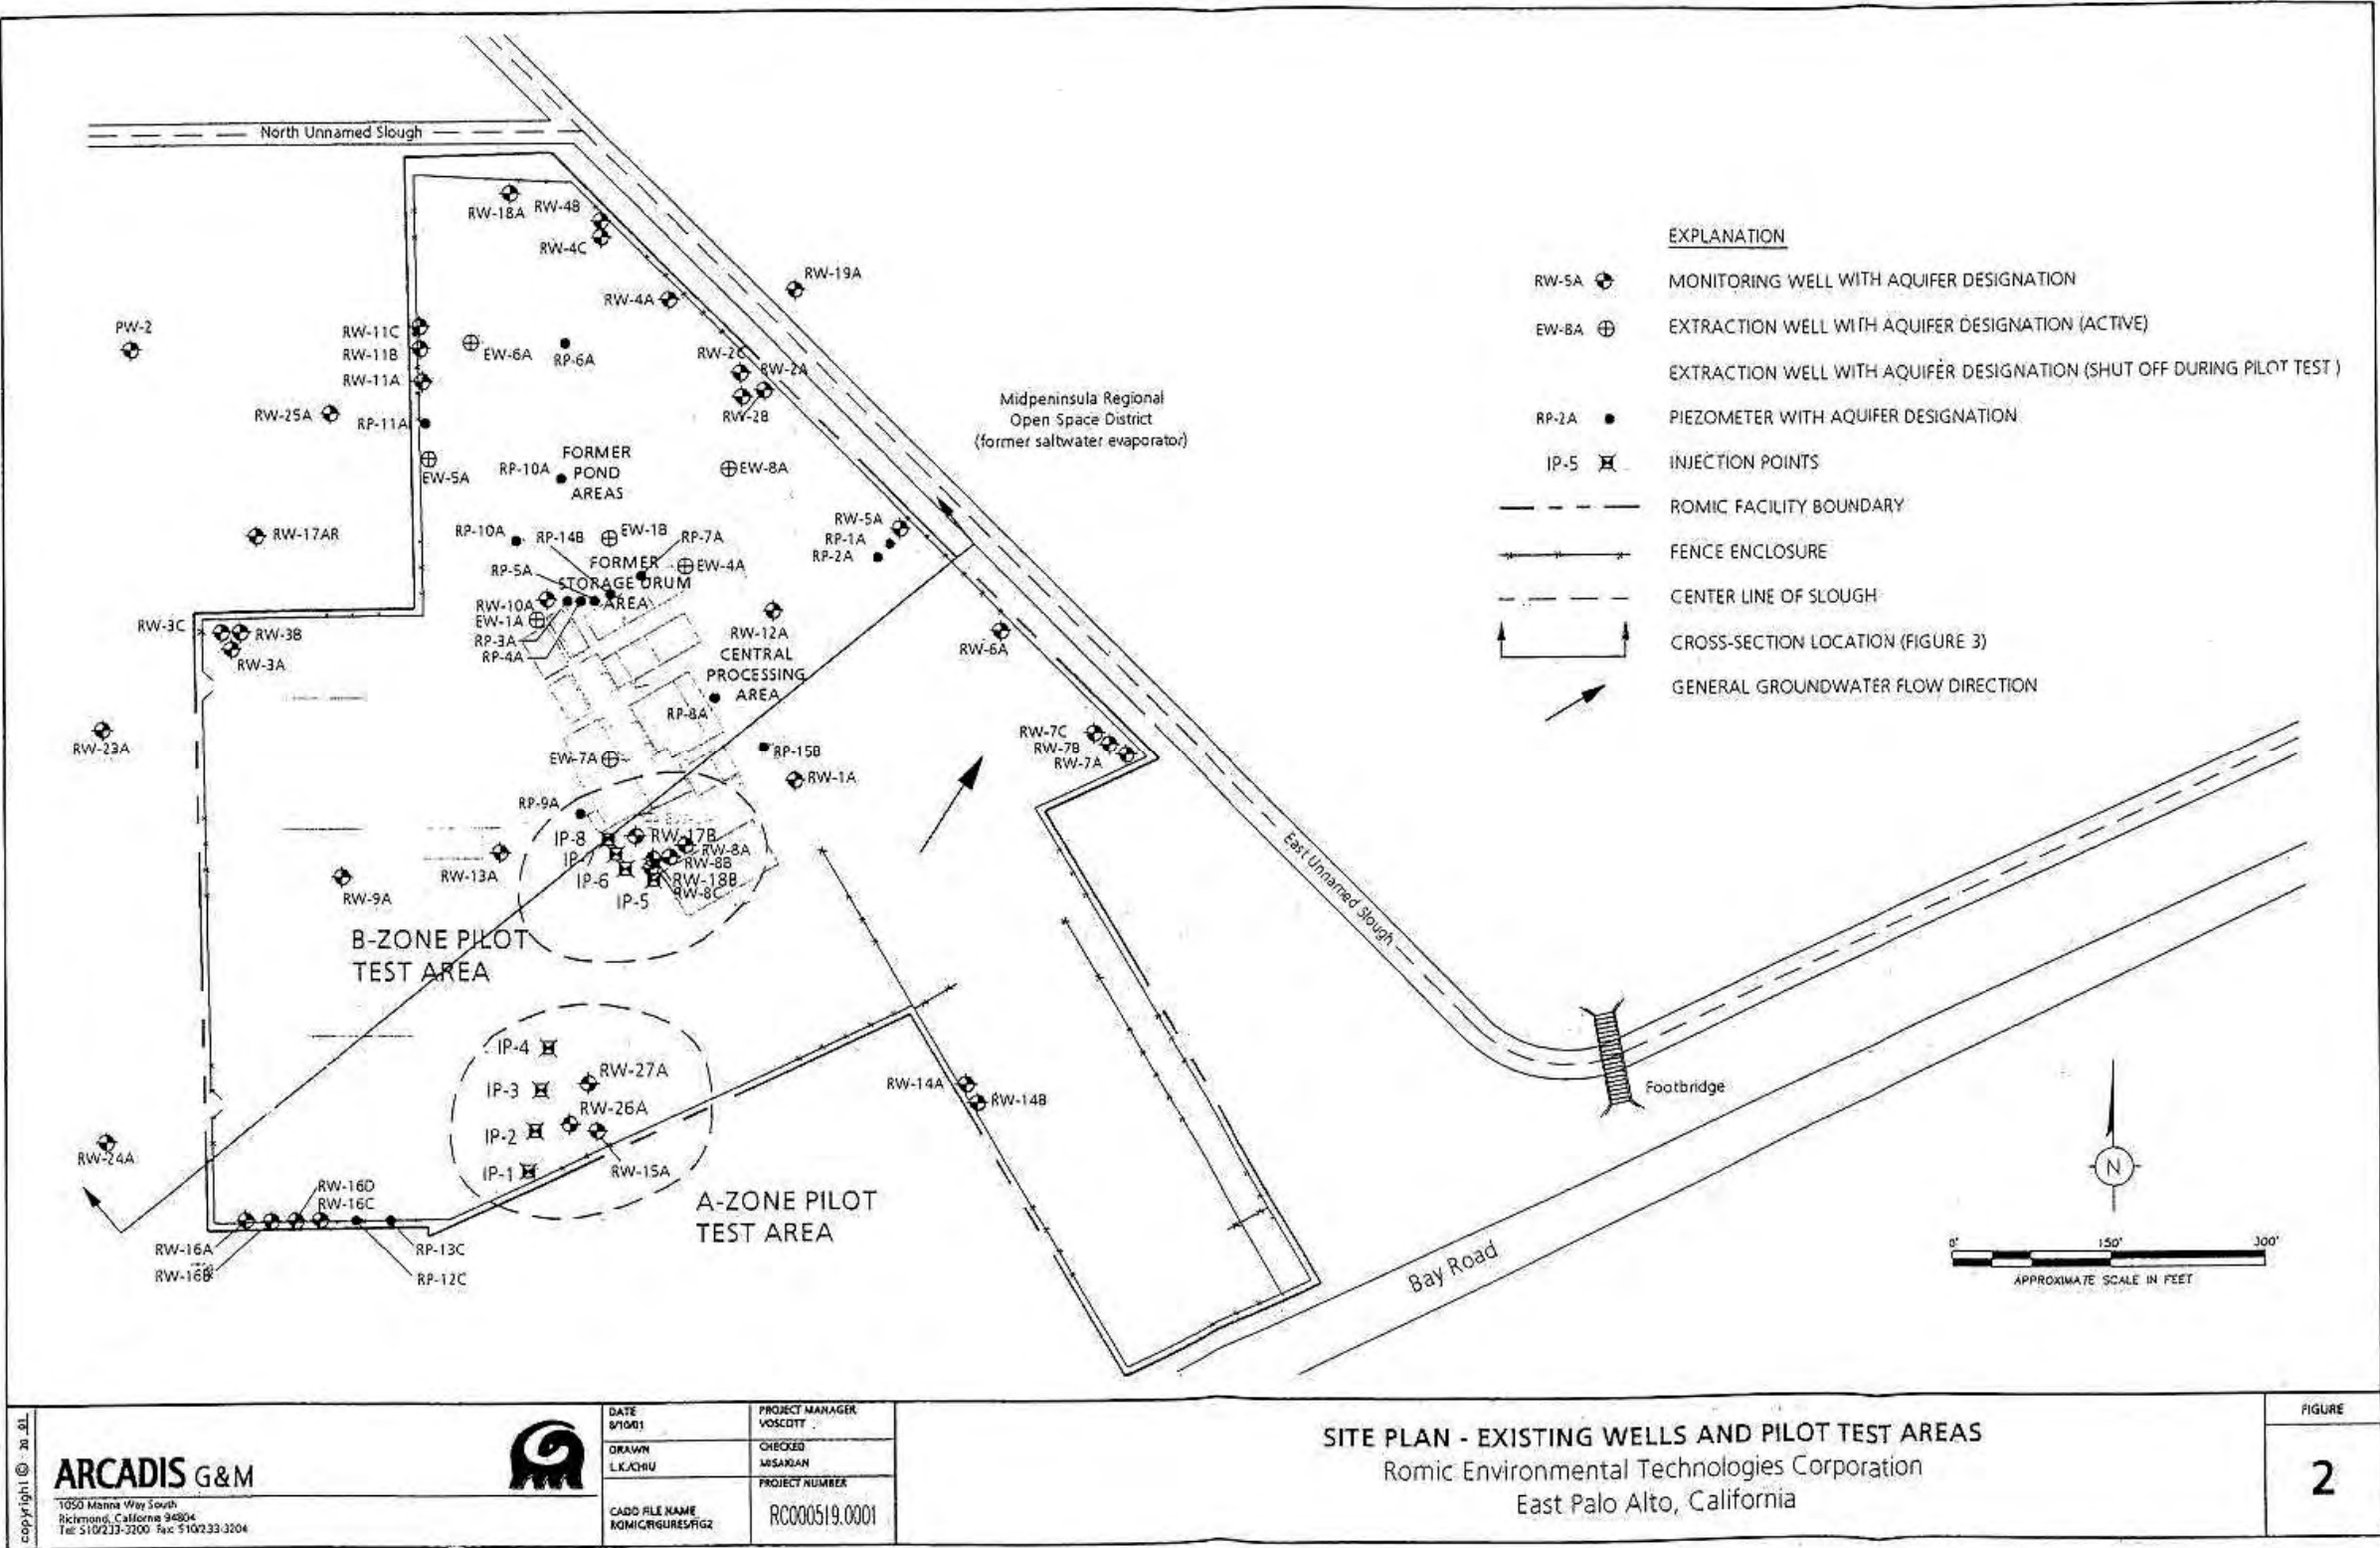
Figure 4-9. Monitoring and Injection Wells at the Romic Facility

Based on the results of the pilot study, U.S. EPA has installed ISB injection wells in the area of RW-2A/2B/2C as an interim remedy. The area around RW-2A/2B/2C is considered a hot spot for chlorinated and non-chlorinated solvents. Twelve injection wells have been installed around RW-2A/2B/2C with six wells in the A-zone and six wells in the B-zone. The proposed substrate will be a mixture of molasses, cheese whey, and water. The ratio of each component was not available. As of 8/11/2003, no injection events have been conducted at the site.

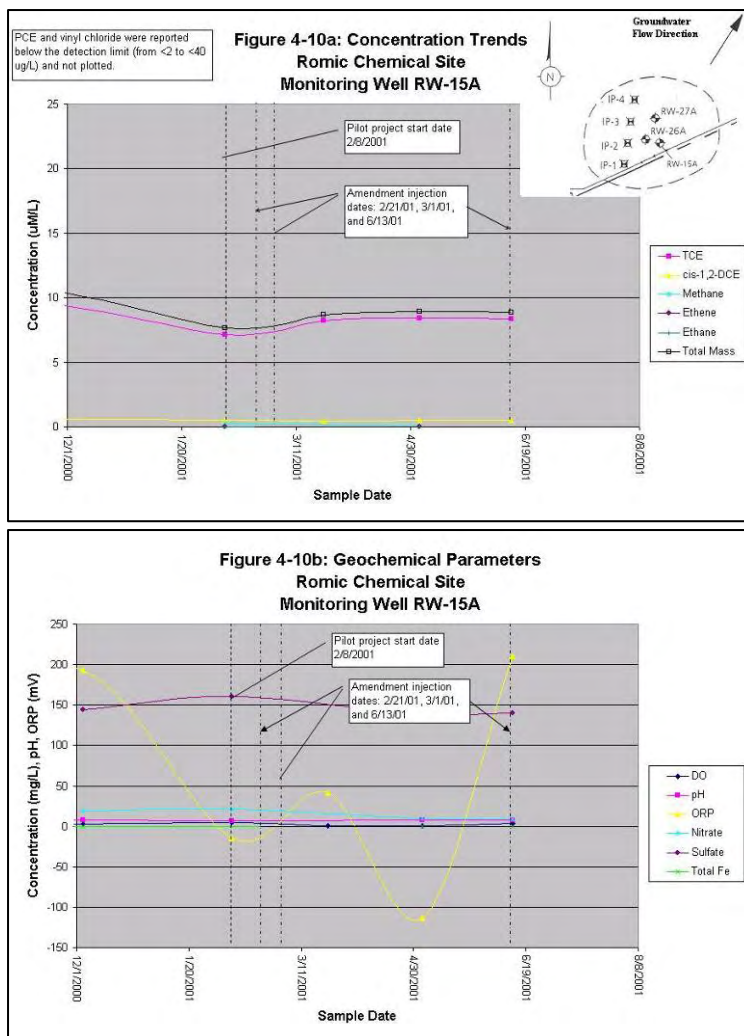
Figure 4-10. Data Analyses for Monitoring Well RW-15A at Romic Chemical

Well Number	Contaminant Mass Loss				Enhanced Geochemical Conditions	Increased Dissolved Gases	Evaluation Rating
	PCE	TCE	DCE	VC			
RW-15A		-	0		-	-	NE

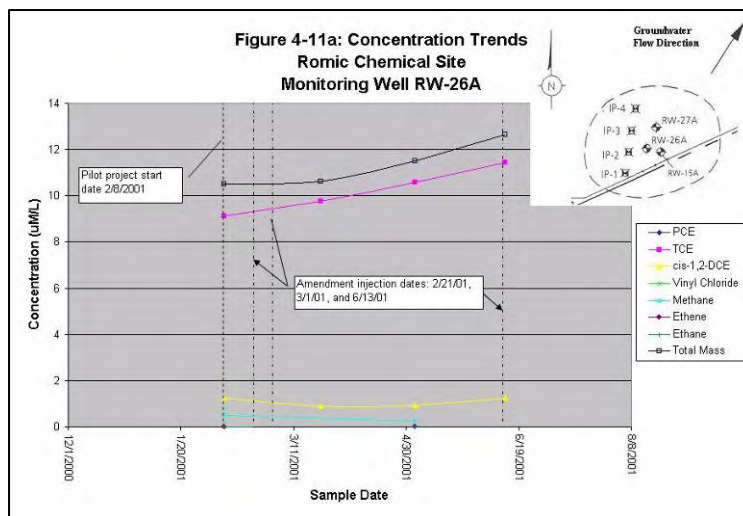
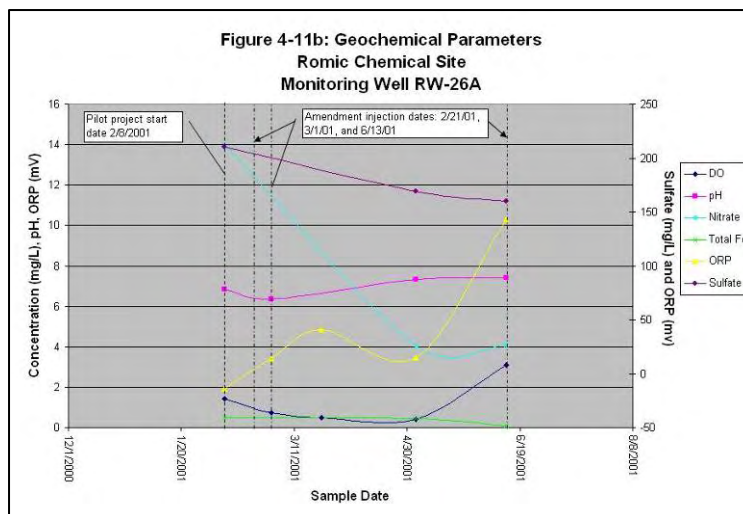
Figure 4-11. Data Analyses for Monitoring Well RW-26A at Romic Chemical

Well Number	Contaminant Mass Loss				Enhanced Geochemical Conditions	Increased Dissolved Gases	Evaluation Rating
	PCE	TCE	DCE	VC			
RW-26A	-	-	0		+	-	SE

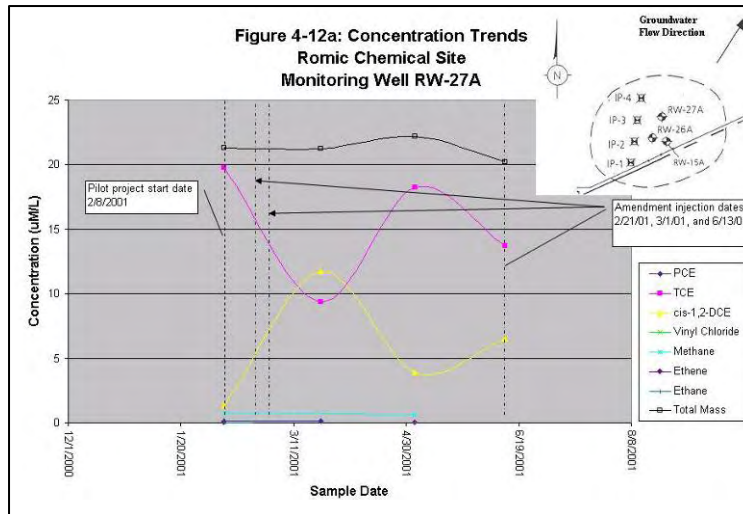
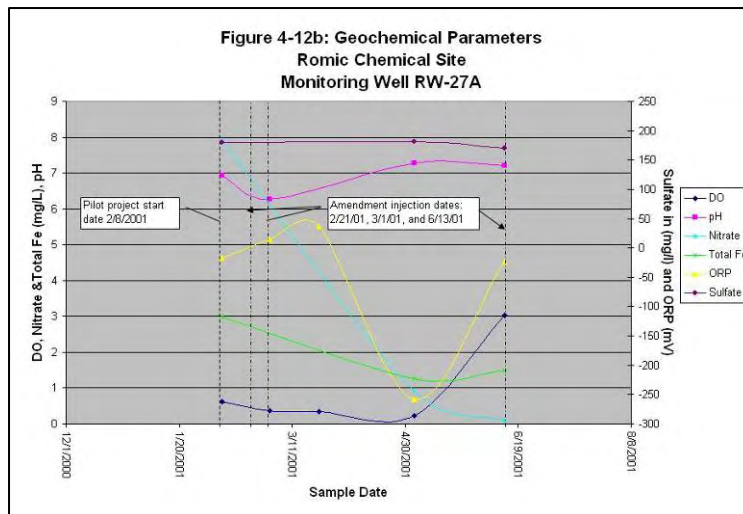
Figure 4-12. Data Analyses for Monitoring Well RW-27A at Romic Chemical

Well Number	Contaminant Mass Loss				Enhanced Geochemical Conditions	Increased Dissolved Gases	Evaluation Rating
	PCE	TCE	DCE	VC			
RW-27A	0	+	+		+	-	ME

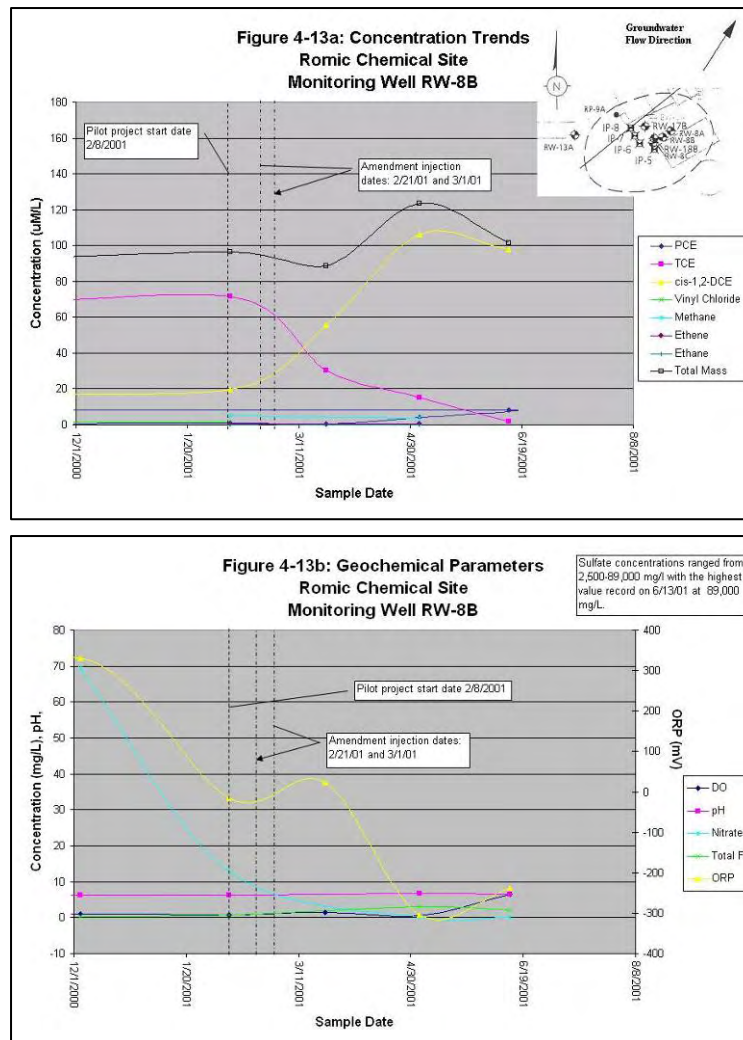
Figure 4-13. Data Analyses for Monitoring Well RW-8B at Romic Chemical

Well Number	Contaminant Mass Loss				Enhanced Geochemical Conditions	Increased Dissolved Gases	Evaluation Rating
	PCE	TCE	DCE	VC			
RW-8B	0	+	+	0	+	-	ME

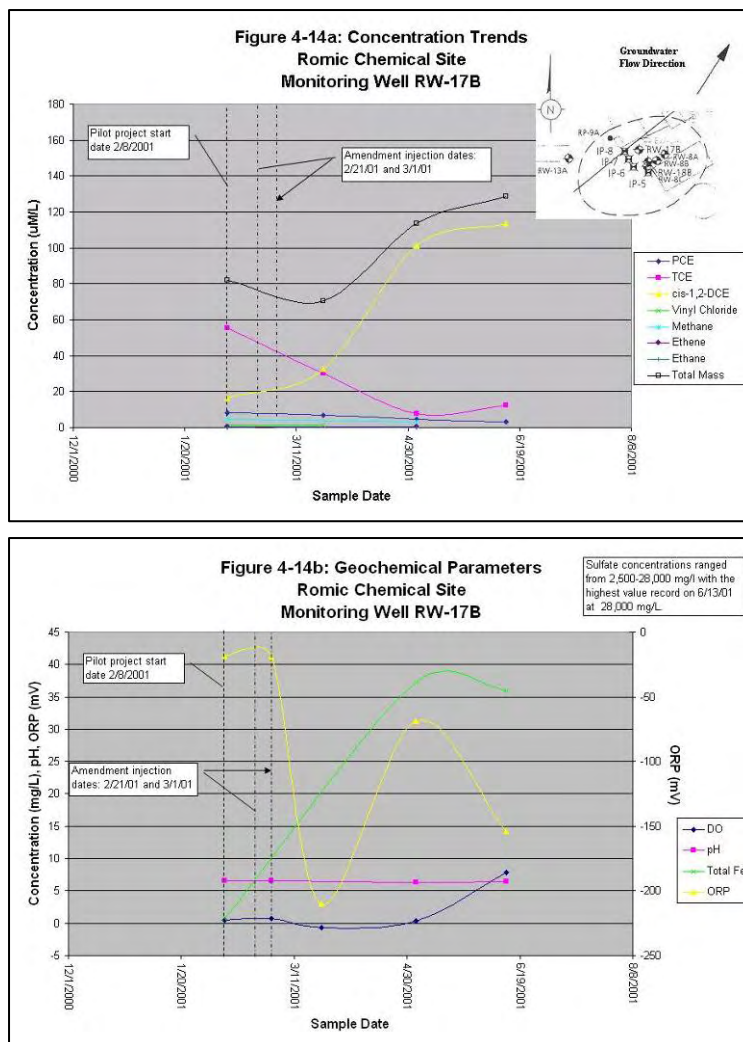
Figure 4-14. Data Analyses for Monitoring Well RW-17B at Romic Chemical

Well Number	Contaminant Mass Loss				Enhanced Geochemical Conditions	Increased Dissolved Gases	Evaluation Rating
	PCE	TCE	DCE	VC			
RW-17B	0	+	+	0	+	-	ME

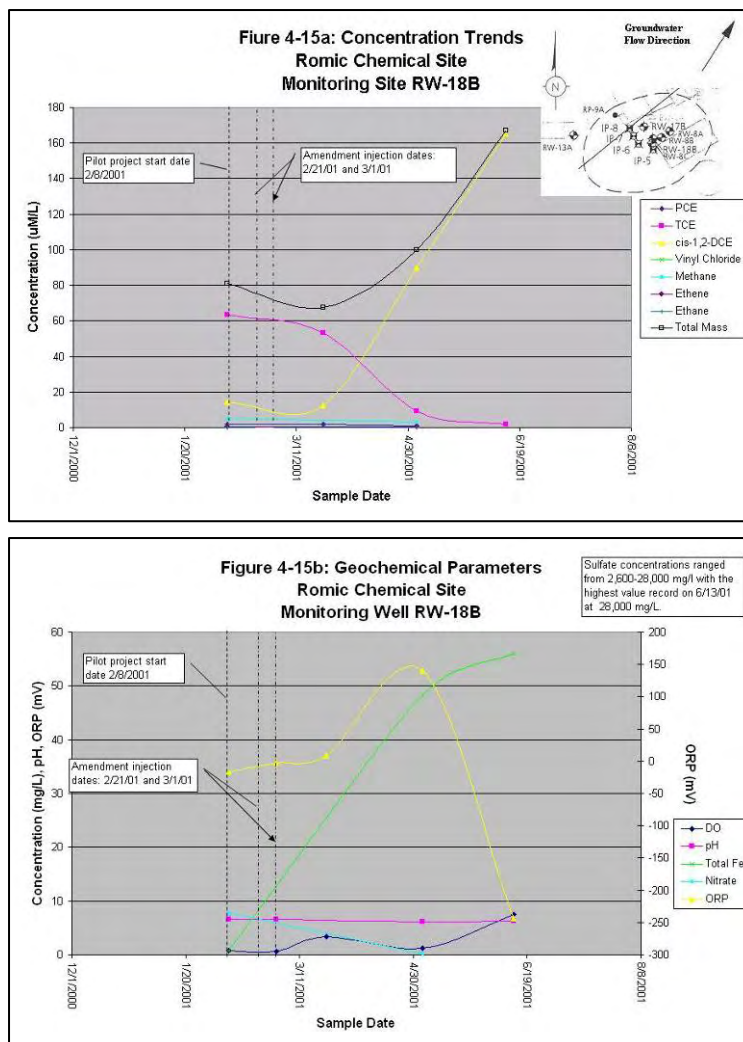
Figure 4-15. Data Analyses for Monitoring Well RW-18B at Romic Chemical

Well Number	Contaminant Mass Loss				Enhanced Geochemical Conditions	Increased Dissolved Gases	Evaluation Rating
	PCE	TCE	DCE	VC			
RW-18B	0	+	+		+	-	ME

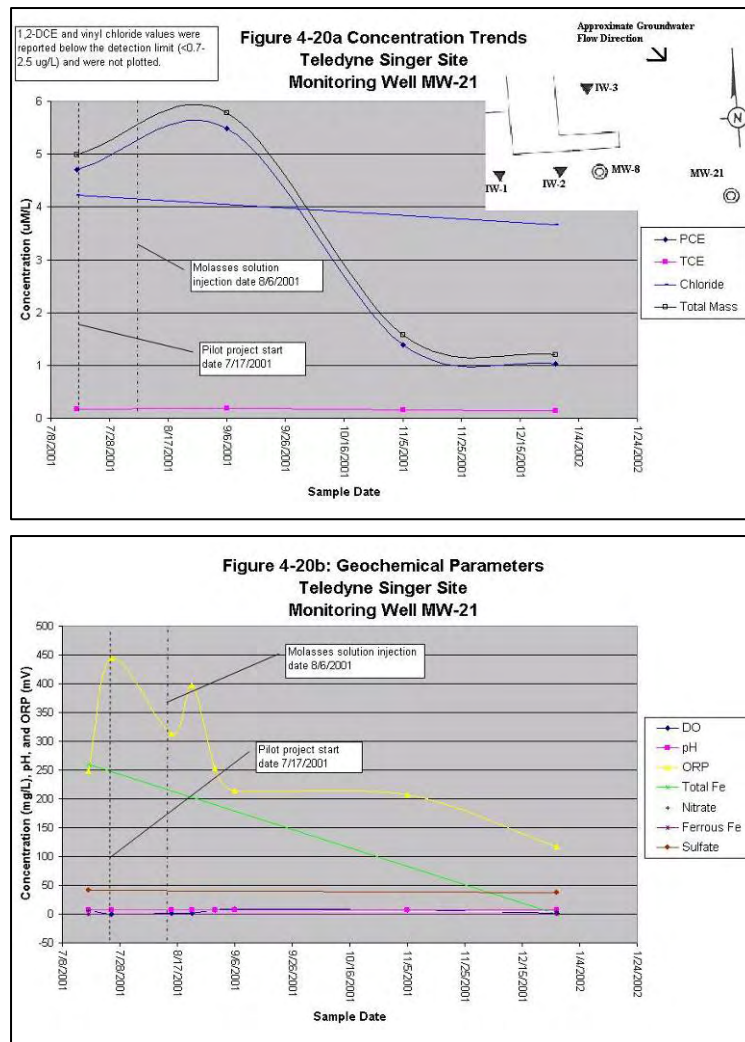
Figure 4-20. Data Analyses for Monitoring Well MW-21 at the Teledyne Singer Site

Well Number	Contaminant Mass Loss				Enhanced Geochemical Conditions	Increased Dissolved Gases	Evaluation Rating
	PCE	TCE	DCE	VC			
MW-21	+	0			-		SE

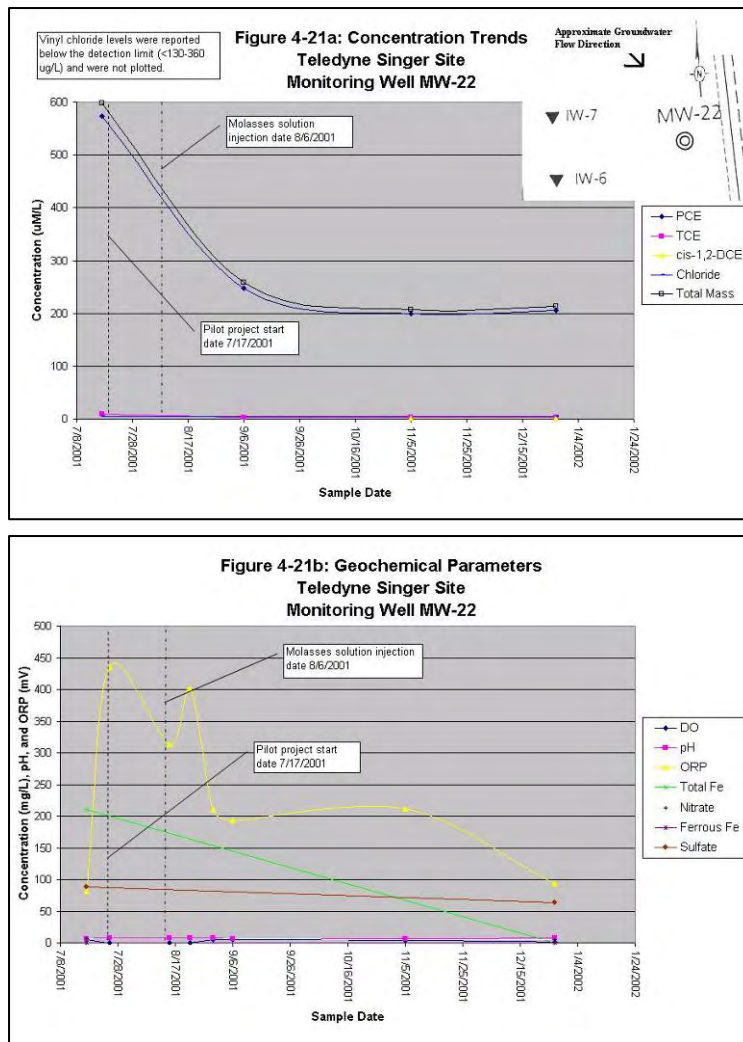
Figure 4-21. Data Analyses for Monitoring Well MW-22 at the Teledyne Singer Site

Well Number	Contaminant Mass Loss				Enhanced Geochemical Conditions	Increased Dissolved Gases	Evaluation Rating
	PCE	TCE	DCE	VC			
MW-22	+	0	0		+		SE

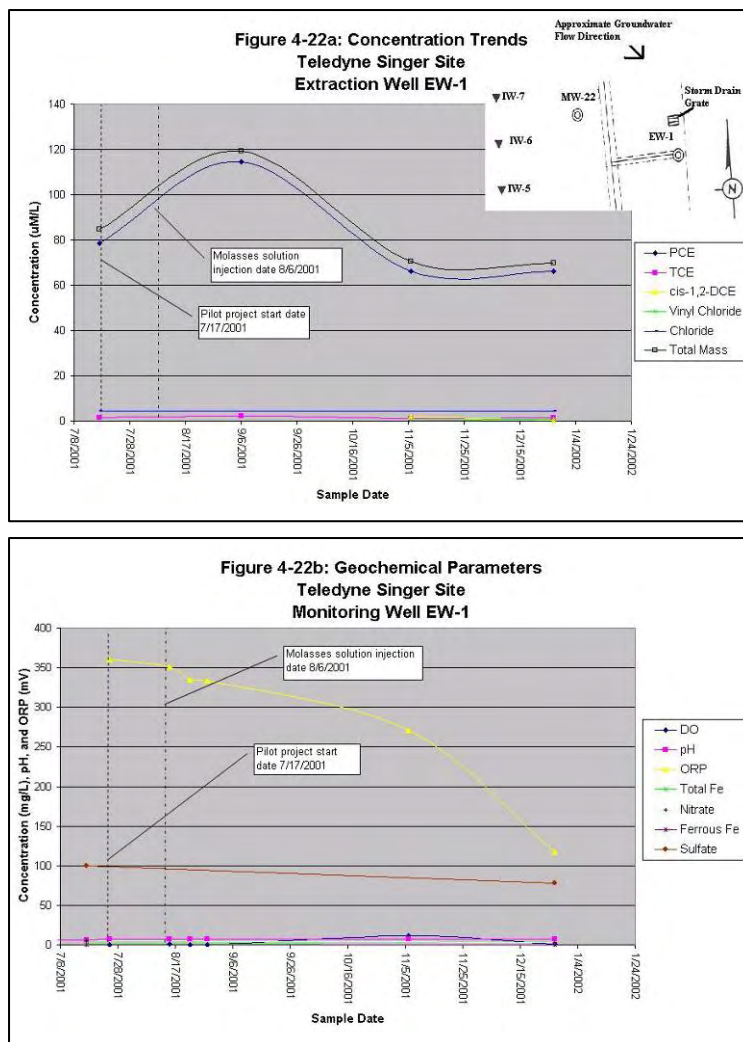
Figure 4-22. Data Analyses for Monitoring Well EW-1 at the Teledyne Singer Site

Well Number	Contaminant Mass Loss				Enhanced Geochemical Conditions	Increased Dissolved Gases	Evaluation Rating
	PCE	TCE	DCE	VC			
EW-1	+	0	-	+	-		SE

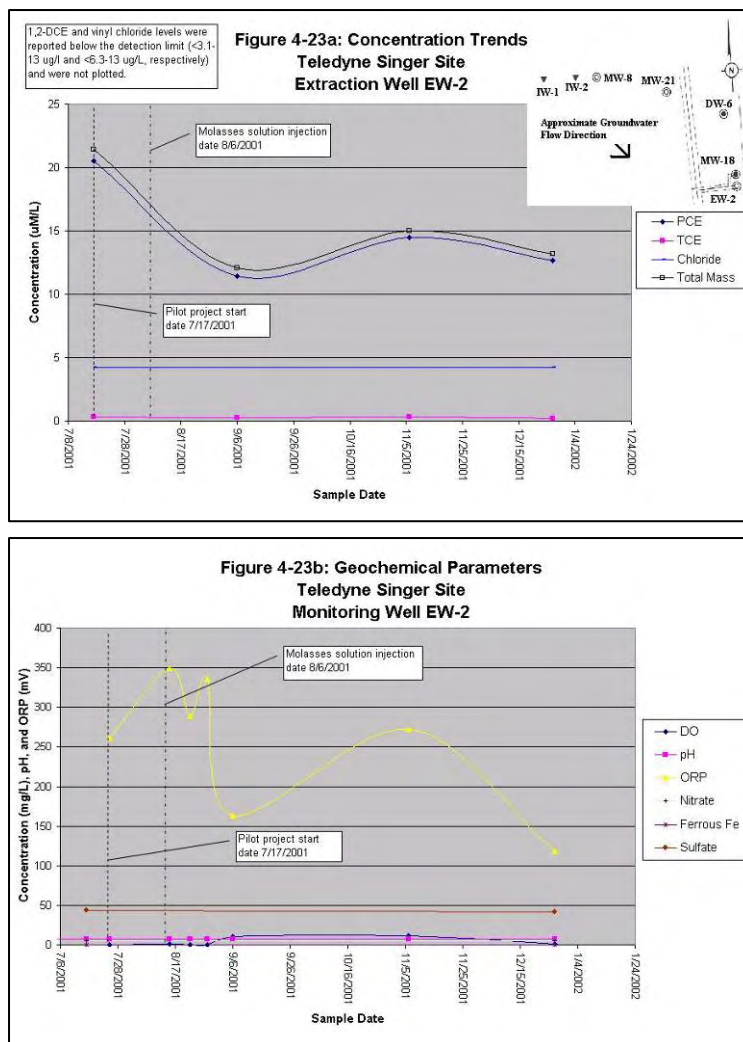
Figure 4-23. Data Analyses for Monitoring Well EW-2 at the Teledyne Singer Site

Well Number	Contaminant Mass Loss				Enhanced Geochemical Conditions	Increased Dissolved Gases	Evaluation Rating
	PCE	TCE	DCE	VC			
EW-2	+	0			-		SE

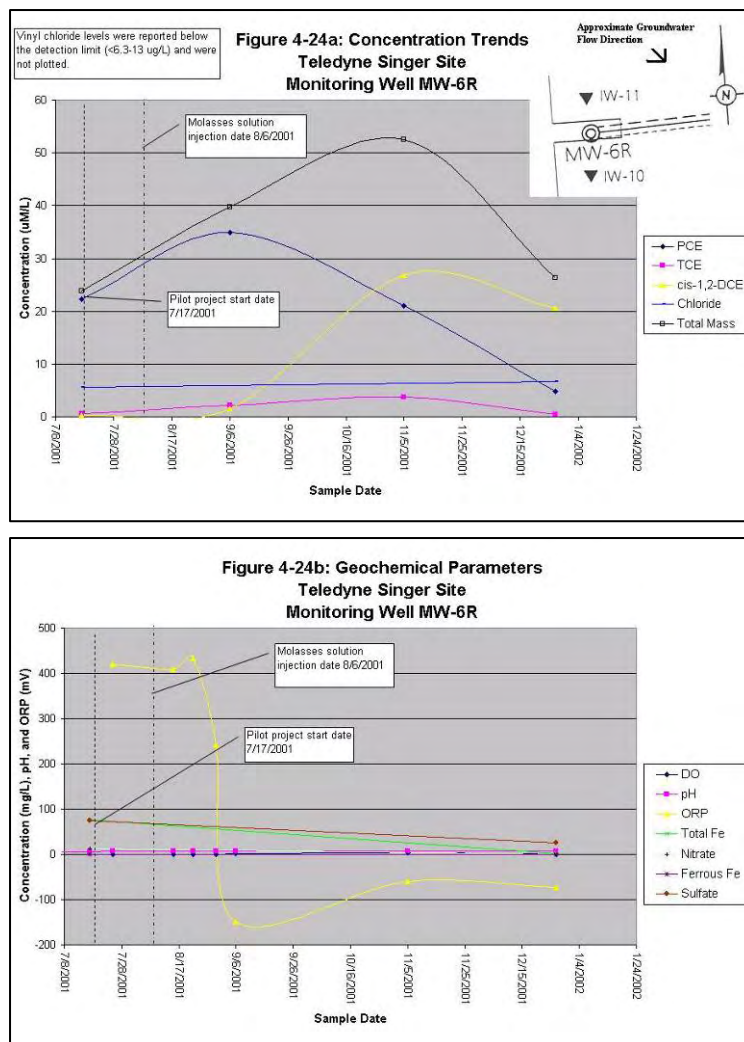
Figure 4-24. Data Analyses for Monitoring Well MW-6R at the Teledyne Singer Site

Well Number	Contaminant Mass Loss				Enhanced Geochemical Conditions	Increased Dissolved Gases	Evaluation Rating
	PCE	TCE	DCE	VC			
MW-6R	+	0	+		+		ME
